# Manhole Inspection Summary

Manhole # S47I\_\_047MH

Insp Date: **4/17/08 12:48 PM**

**Location** Address: **302 s maderia st**

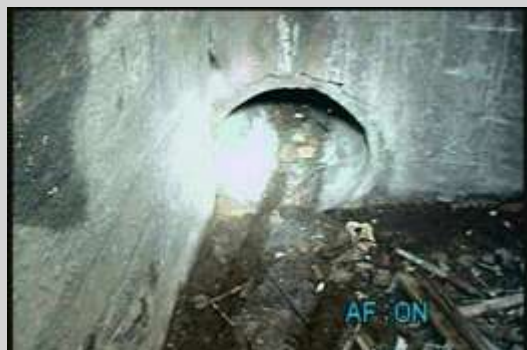
12 O'Clock Outflow

8 in. Circular Gravity Sewer  
Pipe Out @ 12 O'Clock

Infiltration: **None** Pipe Seal Cond: **Unknown**
